Tesla, Inc. Service Bulletin		<h2>Inspect Dash Crossmember for Presence of a Crack</h2>	
SB-24-10-007 September 27, 2024			
Classification		Section/Group	Mobile Service
Campaign Bulletin		10 - Body	Cannot Perform
			Configuration
			All
Model	Model Year	Country/Region	Build Location
Model Y	2024	Europe, Middle East	Giga Berlin
<small>The model(s) and model year(s) listed are a general approximation of the affected VIN list. Refer to the VIN/Bulletin Tracker or Customer/Vehicle profile to determine applicability of this bulletin for a particular vehicle.</small>

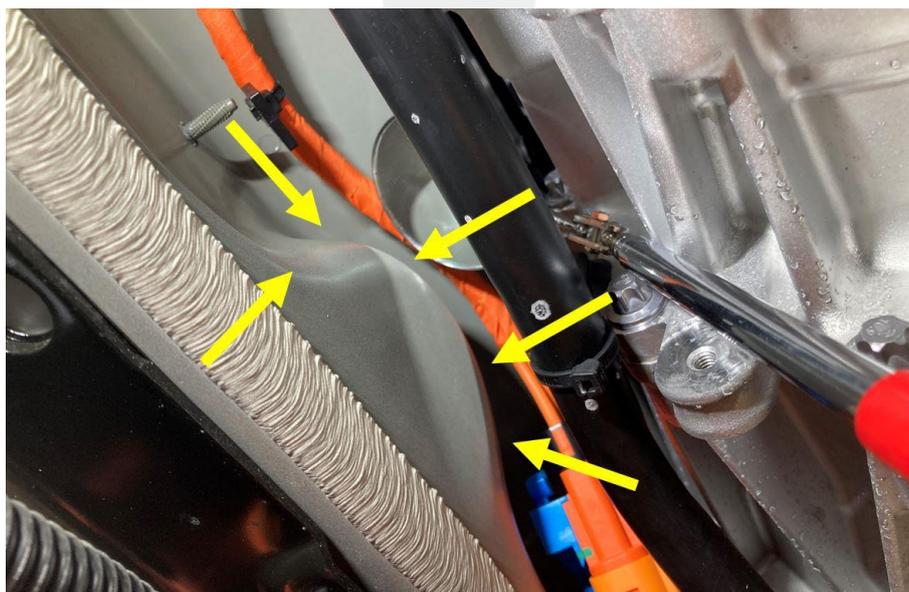
7. Inspect the dash crossmember for the presence of a crack at the indicated location (refer to Figures 2 - 4).

Figure 2 – Inspection area

NOTE: Inspect the affected area for a crack using both touch and visual inspection. Move your hand around the dome and move the HV cable aside, if needed. The use of a small inspection mirror and flashlight may aid in identifying the crack.

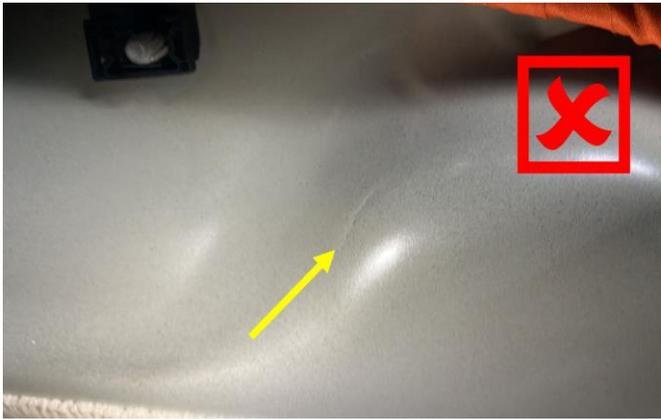
On some Model Y vehicles built at Giga Berlin, there may be a crack in the dash crossmember that allows for corrosion and water ingress into the vehicle interior. The crack does not impact the structural integrity of the vehicle.

Figure 3 – Minor crack

Inspect the vehicle for symptoms related to the condition. If symptoms are present, apply a butyl patch to the dash crossmember to cover the crack.

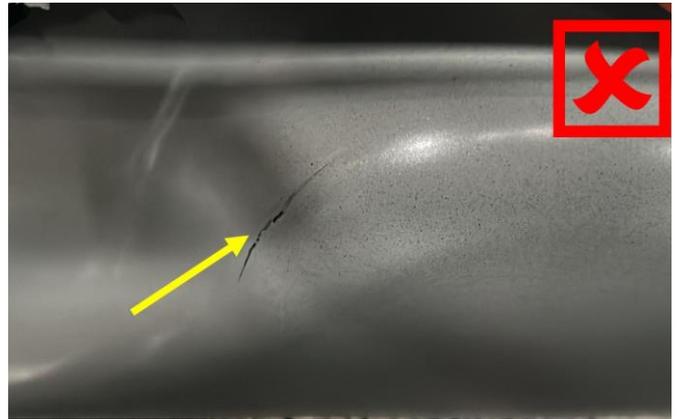
Figure 4 – More severe crack

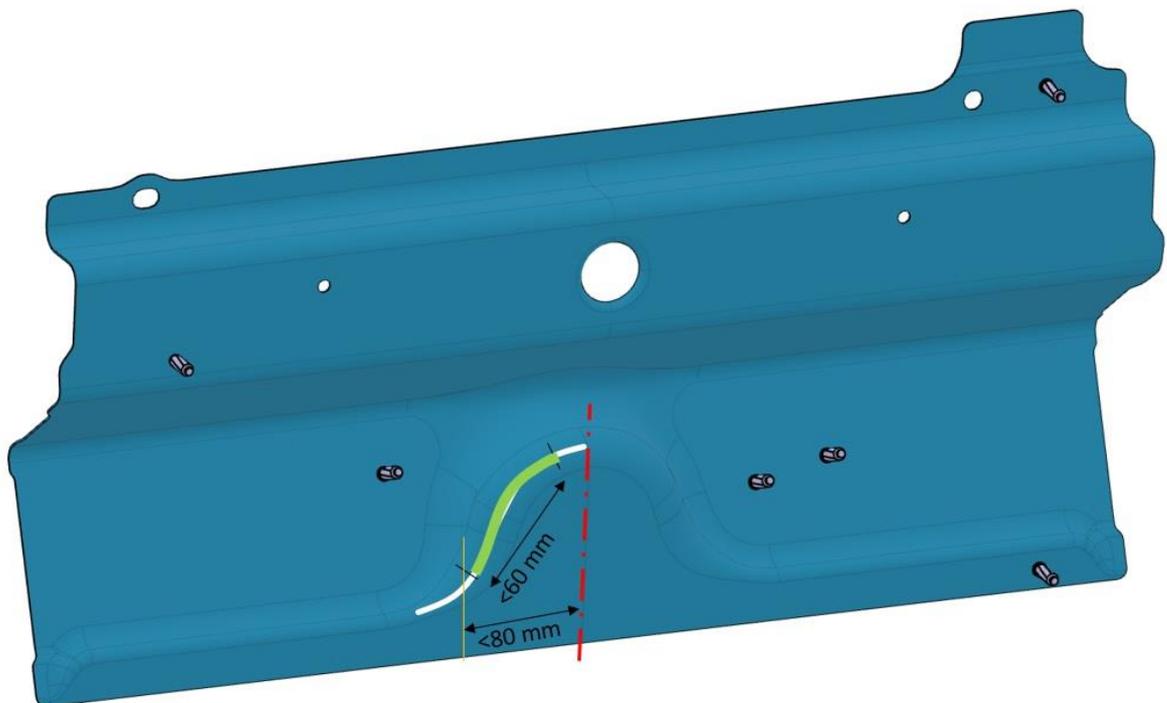
- If no crack is found, reinstall all parts previously removed, and then discontinue this procedure. Use correction code S012410007.
- If a crack is found that has a length of less than 60 mm and the furthest end of the crack is within 80 mm from the dash crossmember center line (Figure 5), continue to the [Rework Procedure](#).
- If a crack is found that has a length of more than 60 mm and/or the crack extends beyond 80 mm from the dash crossmember center line (Figure 5), contact EMEAServiceCampaignsCompliance@tesla.com for further advice. Use correction code S032410007.

Figure 5 – Crack area boundaries on crossmember dash panel
