Tesla, Inc.
Service Bulletin

Inspect and Rework Liftgate Sealant

SB-24-10-008

November 6, 2024

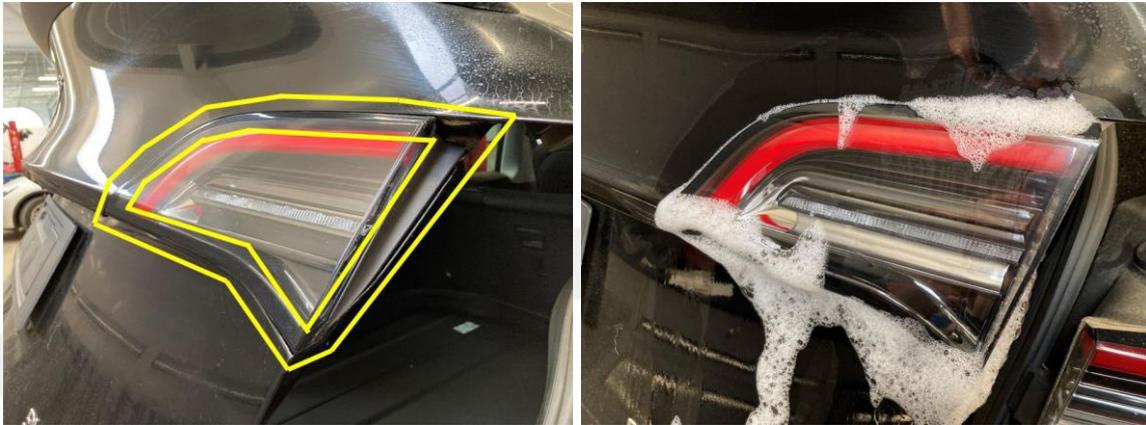
Figure 1 – RH shown, LH similar

1. Remove the liftgate upper and lower trim (refer to Service Manual procedure [15111302](#)).
2. Shake a soapy water solution in a plastic bottle to build up bubble mass, and then apply a small amount of soapy water along the edge of the LH and RH rear fog/reverse lights (Figure 1).

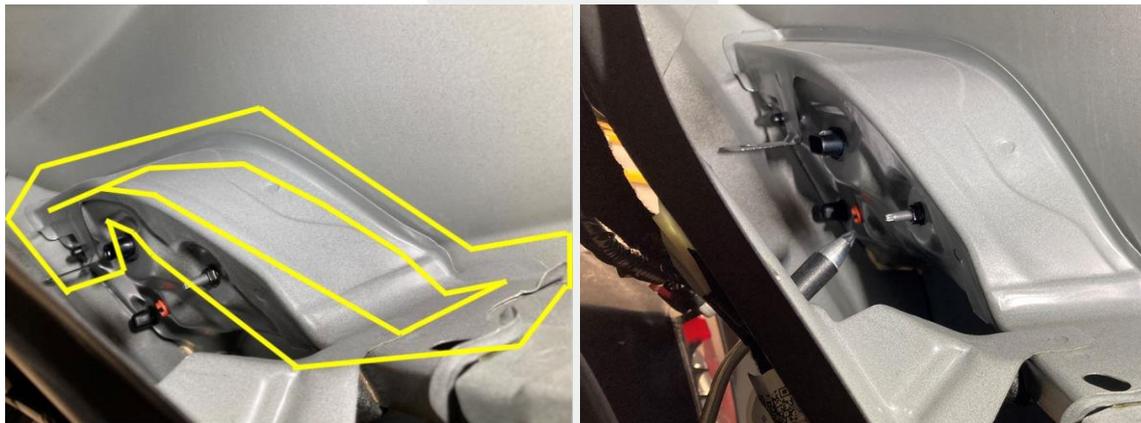
Figure 2 – RH shown, LH similar

3. Blow pressurized air at the inside of the liftgate, at the rear of the LH and RH rear fog/reverse lights, and along the edges of the body panels on LH and RH side (Figure 2).

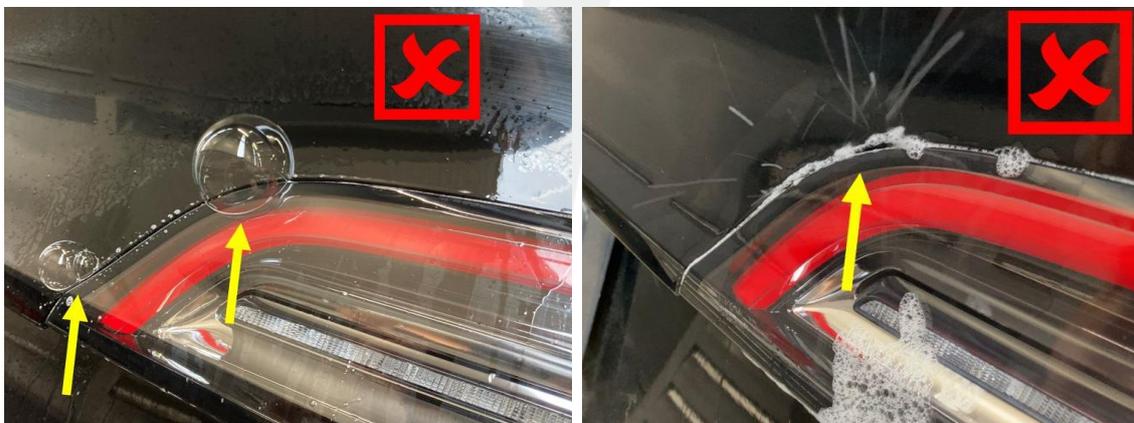
Figure 3 – RH shown, LH similar

4. Inspect the outside of the liftgate for large bubbles (Figure 3) and for foam being blow away (Figure 4).

- If a leak was detected on one or both sides of the liftgate, skip to the [Rework](#) section.
- If no leaks were detected on either side of the liftgate, proceed with the next step.

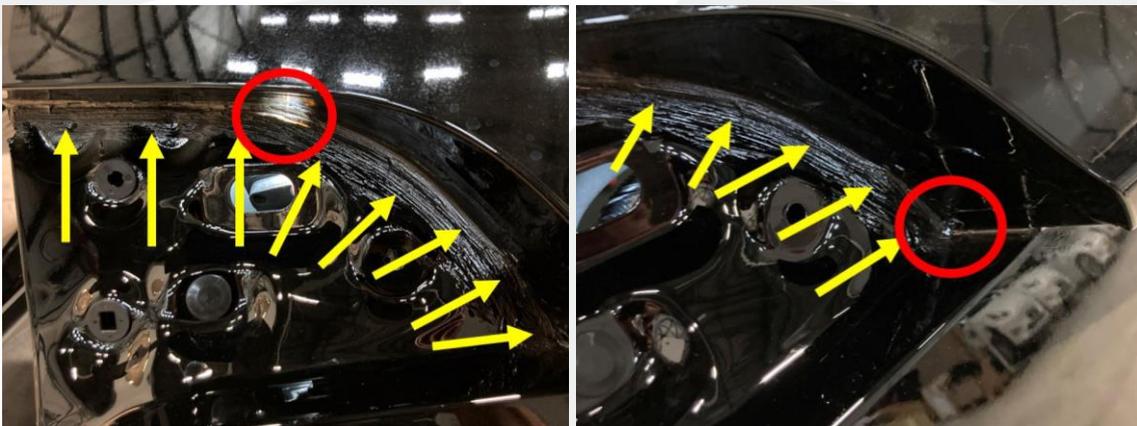
1. Remove the LH and RH rear fog/reverse lights from the liftgate (refer to Service Manual procedure [17402701](#)).
2. Use a small flashlight and look for visible gaps to determine the location of the leak(s) in the indicated areas (Figure 5).

Figure 5 – LH shown, RH similar; Red circles are examples, location may vary

3. If the visual inspection is not successful due to very small gaps, apply a small amount of soapy water in the indicated areas (Figure 5), and then blow pressurized air from the inside of the liftgate to determine the location of the leak(s).
4. Clean the areas with a shop towel, and then use IPA wipes to clean the affected surface of the liftgate.
