Tesla, Inc. Service Bulletin		<h2><i>Inspect and Rework Front Aero Shield</i></h2>	
SB-24-12-009 November 29, 2024			
Classification		Section/Group	Mobile Service
Repair Bulletin		12 - Exterior Fittings	Cannot Perform
Model	Model Year	Country/Region	Build Location
Model 3	All	EMEA	Giga Berlin, Giga Shanghai
Model Y	All		
<small>The model(s) and model year(s) listed are a general approximation of the affected VIN list. Refer to the VIN/Bulletin Tracker or Customer/Vehicle profile to determine applicability of this bulletin for a particular vehicle.</small>

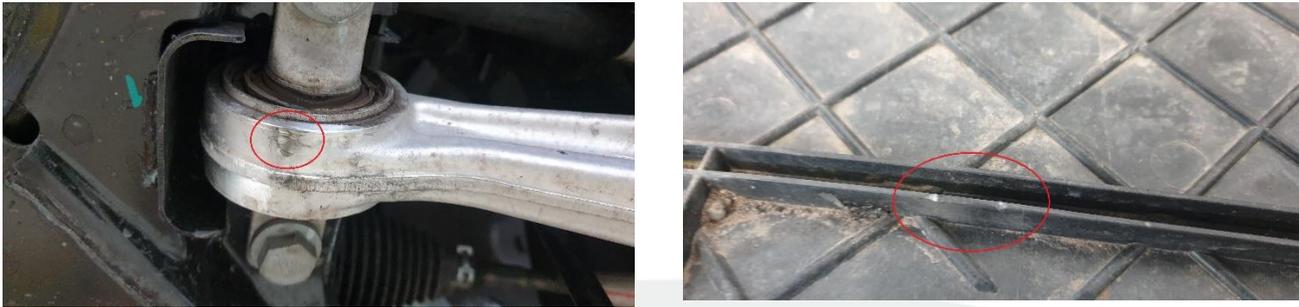
On some Model Y and Model 3 vehicles with a rigid front aero shield, the front aero shield may be slightly deformed/warped, resulting in interference between the aero shield and the lower lateral links, which causes squeaking noises when driving over a speed bump or other irregularity in the road.

Inspect the front aero shield and front lateral links for signs of contact with the LH and/or RH front lateral link (Figure 1).

Figure 1 – Signs of contact between front lateral link and aero shield

- If no signs of contact are found, discontinue this procedure and use correction code S022412009.
- If signs of contact are found, continue with the rework procedure.
