Inspect Instrument Panel Decor Assembly

SB-24-14-002

December 10, 2024

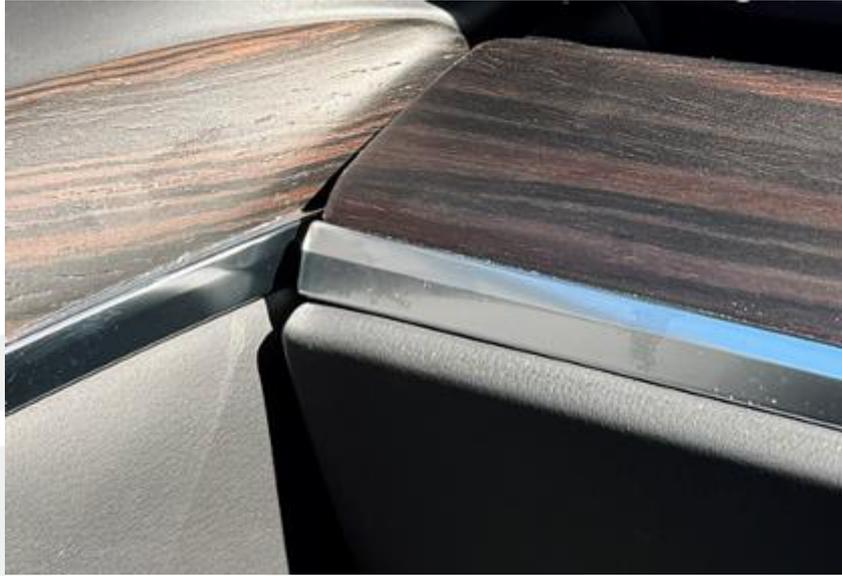
Inspect the IP decor assembly for a mismatch in wood grain and color harmony compared to the door trim (Figure 1).

Figure 1 – Mismatch in wood grain and color harmony between door trim (left) and IP decor assembly (right)

- If a mismatch between the IP decor assembly and door trim wood grain and color is not present, no further action is required. Use correction code S012414002.
- If a mismatch between the IP decor assembly and door trim wood grain and color is present, replace the IP decor assembly with the updated part that matches the door trim (refer to Service Manual procedure [14057002](#)). Use correction code S022414002.
