Tesla, Inc.
Service Bulletin

Replace HW4 Camera Hood

SB-24-15-003

September 27, 2024

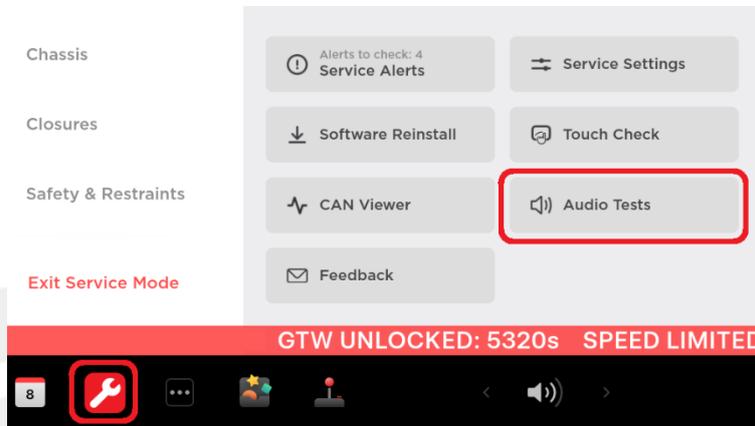
Figure 1

1. Get into the driver seat and make sure all doors and windows are closed.
2. Place the vehicle into Service Mode Plus (refer to Service Manual procedure [00050000](#)).
3. In Service Mode, touch **Controls** > **Audio Tests** (Figure 1).

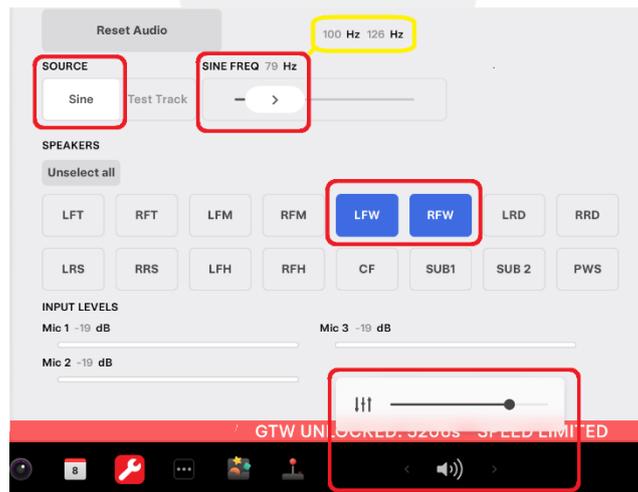
Figure 2

4. Set the 'SOURCE' to **Sine**, set the 'SINE FREQ' to **79 Hz**, set the 'SPEAKERS' to **LFW** and **RFW**, and then set the volume to 75% to play a test sound (Figure 2).
