Tesla, Inc.
Service Bulletin

Inspect Ancillary Harness

SB-24-16-008

December 6, 2024

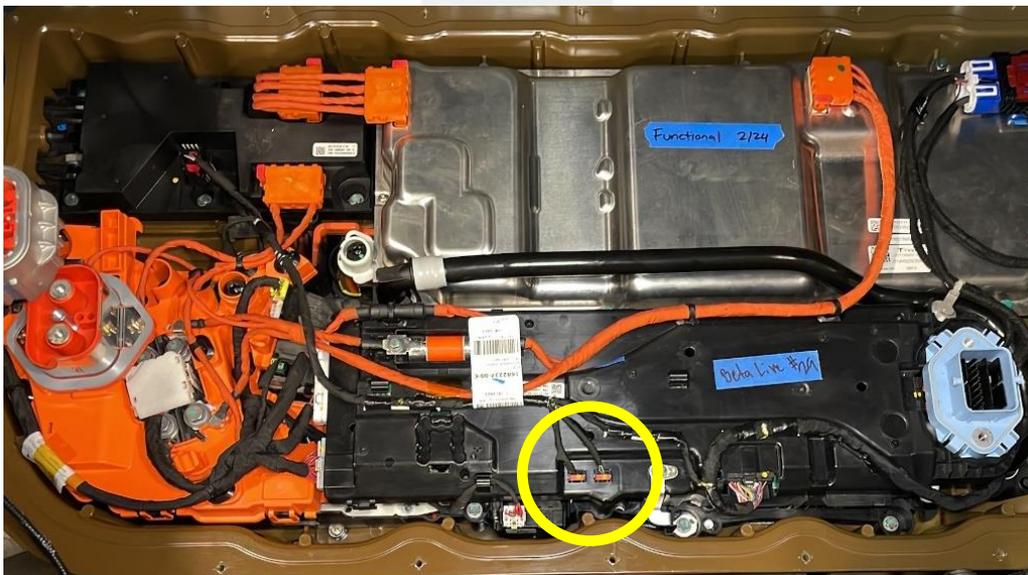
Figure 1

1. Put on HV insulating gloves and leather over gloves.
2. Inspect the (2x) HV battery ancillary harness branches to the BMBs (Figures 1–3). Look closely at the harness bundles, wire terminals, and connector housings.

- If the (2x) ancillary harness branches to the BMBs appear to be in good condition, with no damage to any part of the harness and connectors, skip to step 3 to rework the harness.
- If any of the (2x) ancillary harness branches connecting to the BMBs appear damaged, replace the harness (refer to Service Manual procedure [1710118012](#)). Use correction code S022416008, discontinue this procedure, and then return to the other procedure(s) that required opening the ancillary bay for service.

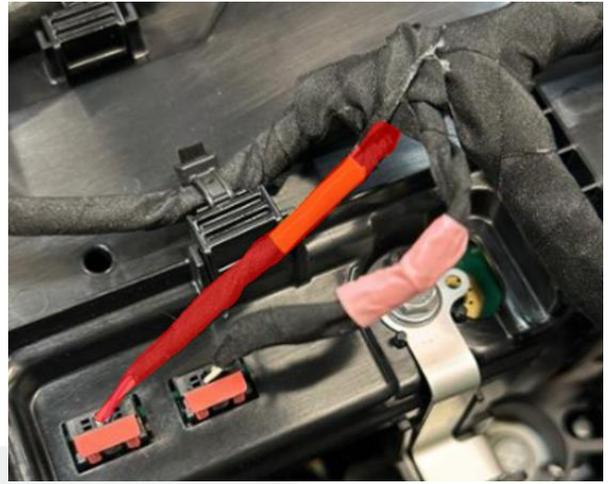
📄 NOTE: The harness branches might be strained or taut (Figure 3). This does not necessarily mean the harness is damaged; but if strain is observed, the harness should be closely inspected.

Figure 3 – A strained harness branch (red) is a sign to check for potential damage
