**Tesla, Inc.**  
Service Bulletin

# Disable Rear Door Cladding Sensors

**SB-21-12-005**

For some Model X vehicles built before May 2018, should water seep into the printed circuit board of the rear door cladding sensor, an alert might be displayed on the touchscreen.

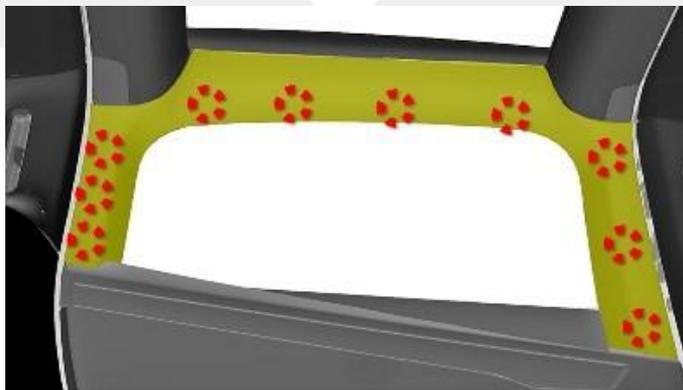
Figure 1

2. Open both rear doors.
3. Release the V-clips (x10) that attach the LH rear lower door garnish to the LH rear door (Figure 1), and then remove the garnish from the vehicle.

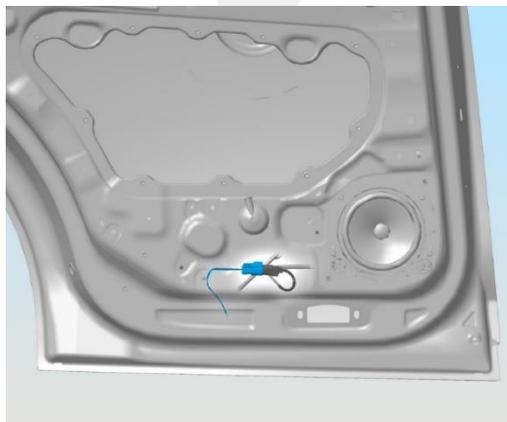
Figure 2

4. Remove the LH rear door trim panel. Refer to Service Manual procedure [15132001](#).
5. Remove the LH rear door speaker. Refer to Service Manual procedure [21211002](#).
6. Use the B-pillar rear door switch to move the LH rear door to a position such that you can see the cladding sensor connector inside the door (Figure 2).

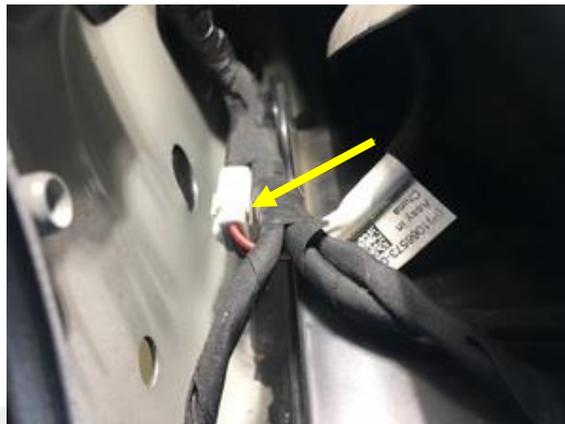
**Figure 3**

7. Disconnect the LH rear door electrical harness from the cladding sensor connector (Figure 3).

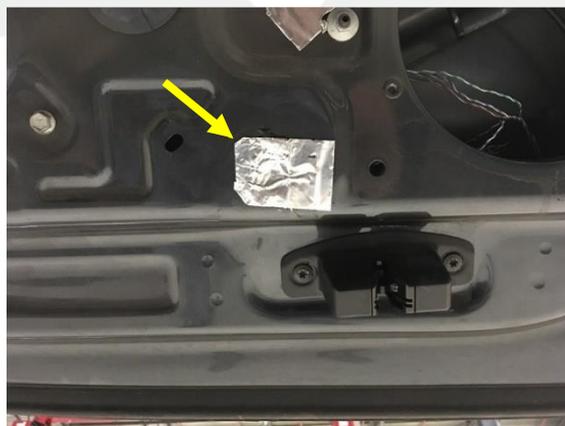
**Figure 4**

8. Remove the lower butyl patch on the inner side of the LH rear door (Figure 4).

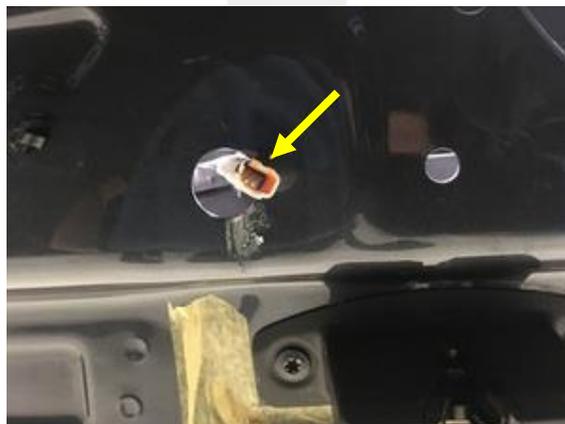
**Figure 5**

9. Guide the LH rear door electrical harness cladding sensor connector through the opening for better access (Figure 5).

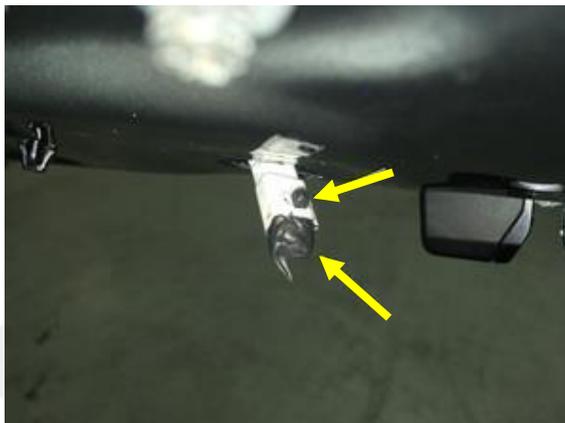
**Figure 6 – LH rear door shown, RH rear door similar**

12. Fill the LH and RH rear door electrical harness cladding sensor connectors fully with Right Stuff sealant (Figure 6).

**⚠ CAUTION:** Make sure to apply the sealant only to the connector.

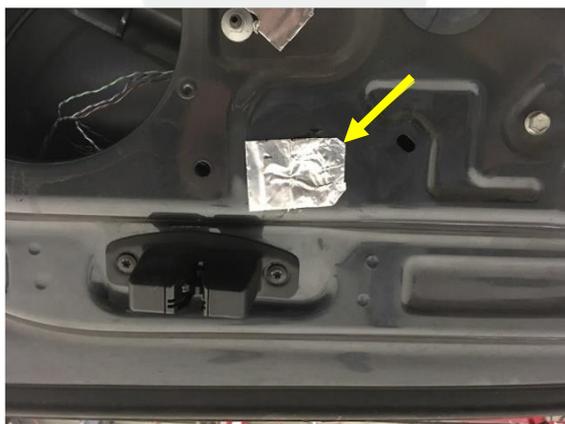
**Figure 7**

14. Install the lower butyl patch onto the inner side of the LH rear door (Figure 7).

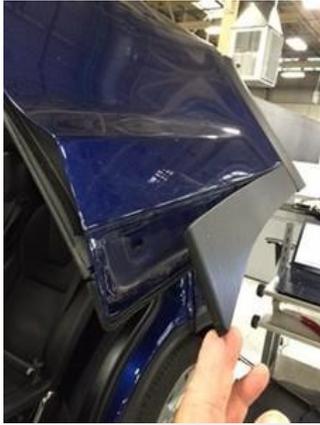
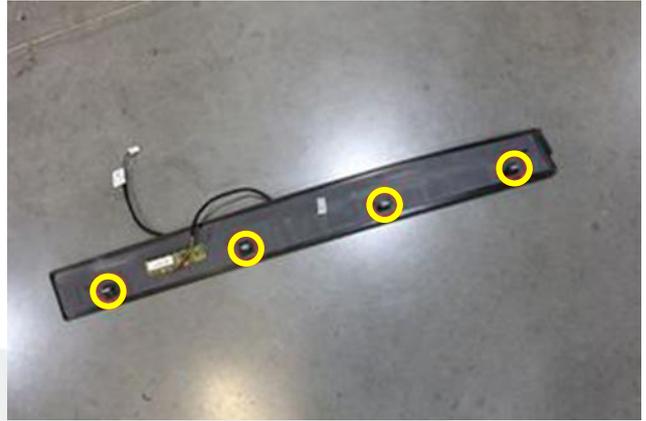
17. Release the clips (x4) that attach the LH rear door cladding sensor to the LH rear door, and then remove the cladding sensor from the door (Figures 8 and 9).

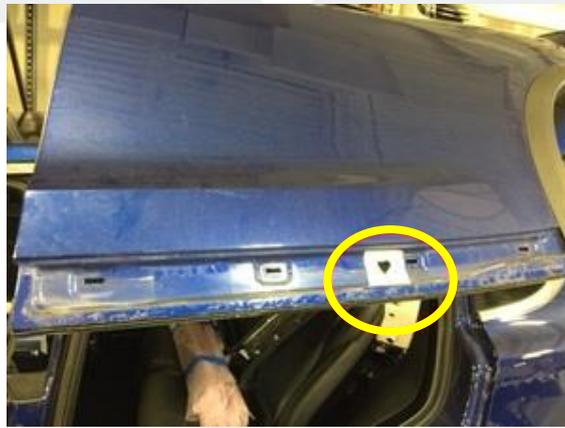
**Figure 10**

18. Remove and discard the butyl patch from the outside of the LH rear door (Figure 10).

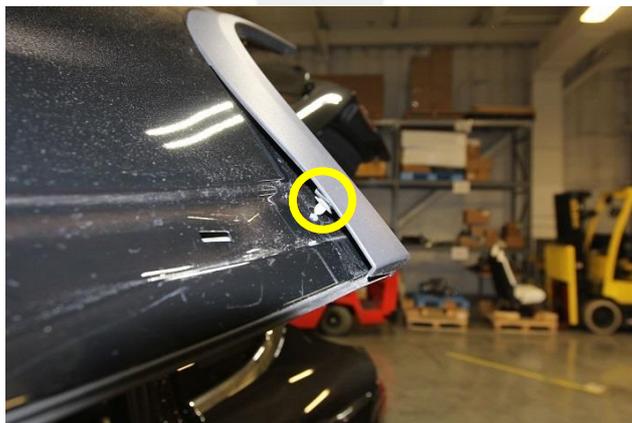
**Figure 11**

19. Release the lower clip that attaches the LH rear wheel arch door cladding to the door (Figure 11).

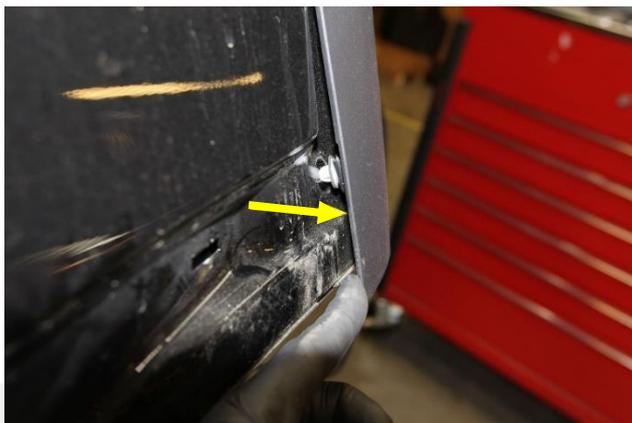
**Figure 12**

20. Use an IPA wipe to clean the backside of the LH rear wheel arch door cladding where double sided tape is applied (Figure 12).

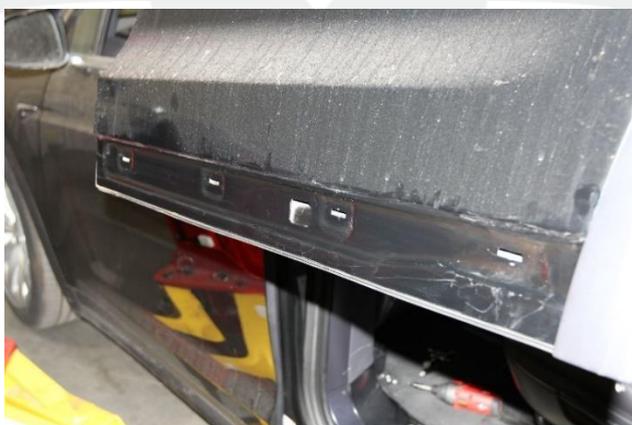
**Figure 13**

21. Use an IPA wipe to clean off the LH rear door cladding mounting surface (Figure 13).

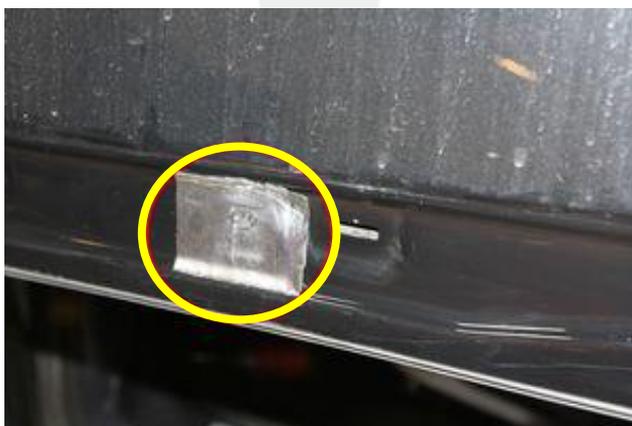
**Figure 14**

22. Install a new butyl patch onto the outside of the LH rear door (Figure 14).

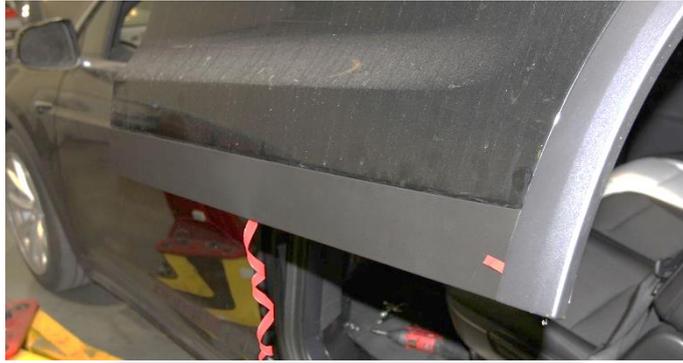
**Figure 15**

24. Peel the backing from the foam tape, install the new LH rear door cladding to the LH rear door, and then fasten the clips (x4) that attach the cladding to the door (Figure 15).

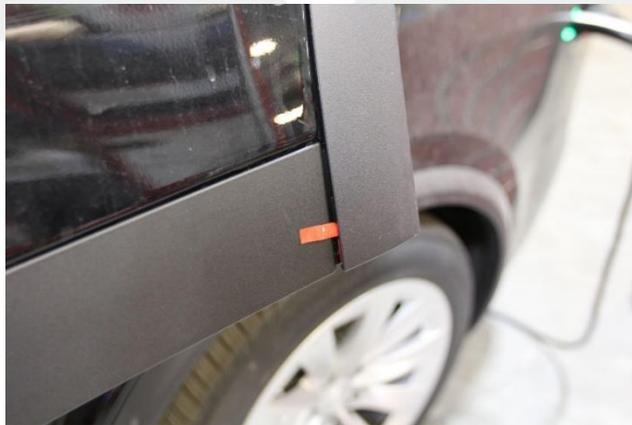
**Figure 16**

25. Install the LH rear wheel arch door cladding to the LH rear door cladding, and then fasten the lower clip that attaches the wheel arch door cladding to the door (Figure 16).

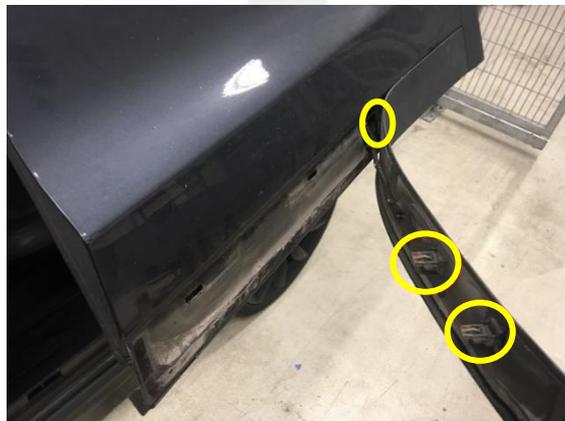
**Figure 17**

27. Release 3 clips to partially remove the LH rear door cladding sensor (Figure 17).

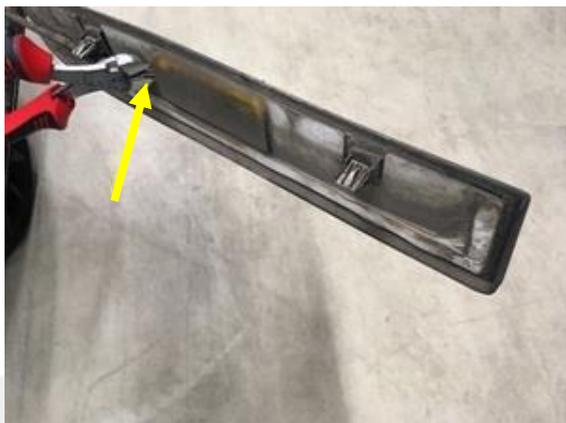
**Figure 18**

28. Use diagonal cutters to cut the LH rear door cladding sensor pigtail as close as possible to the sensor (Figure 18), and then pull the pigtail out of the door.

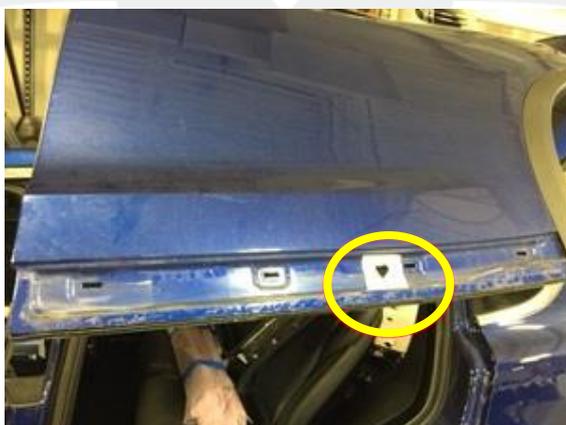
**Figure 19**

29. Remove and discard the butyl patch from the outside of the LH rear door (Figure 19).

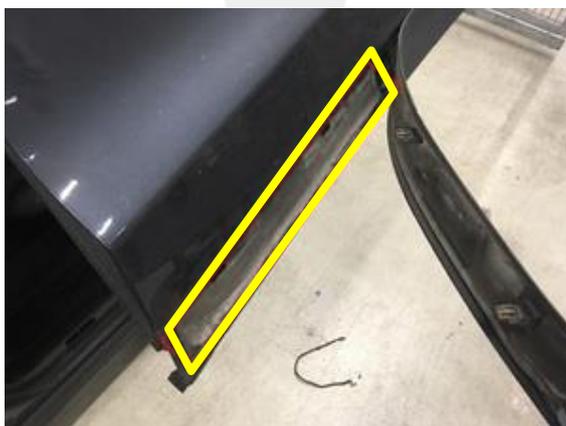
**Figure 20**

30. Use an IPA wipe to clean off the LH rear door cladding mounting surface (Figure 20).

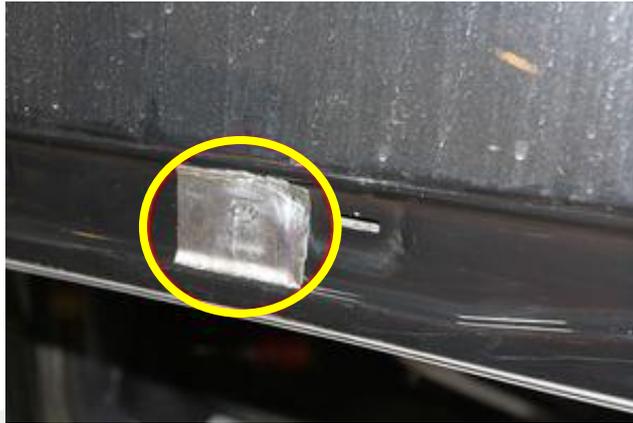
**Figure 21**

31. Install a new butyl patch onto the outside of the LH rear door (Figure 21).

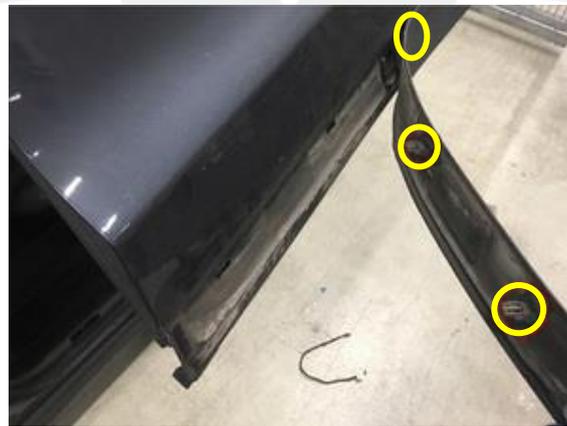
**Figure 22**

32. Use Adhesive Promoter to activate the double sided tape, and then fasten the clips (x3) that attach the LH rear door cladding to the LH rear door (Figure 22).

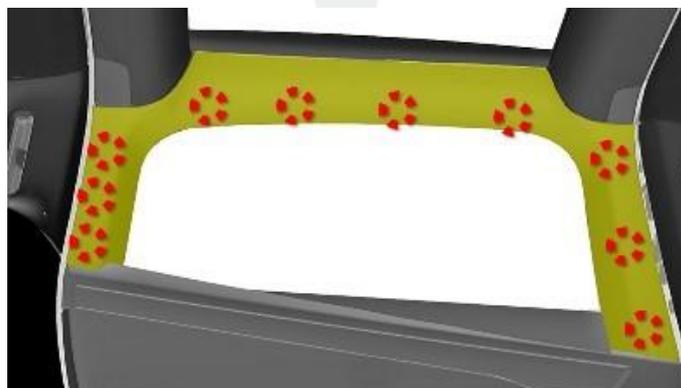
**Figure 23**

35. Install the LH rear lower door garnish to the LH rear door, and then fasten the V-clips (x10) that attach the garnish to the door (Figure 23).

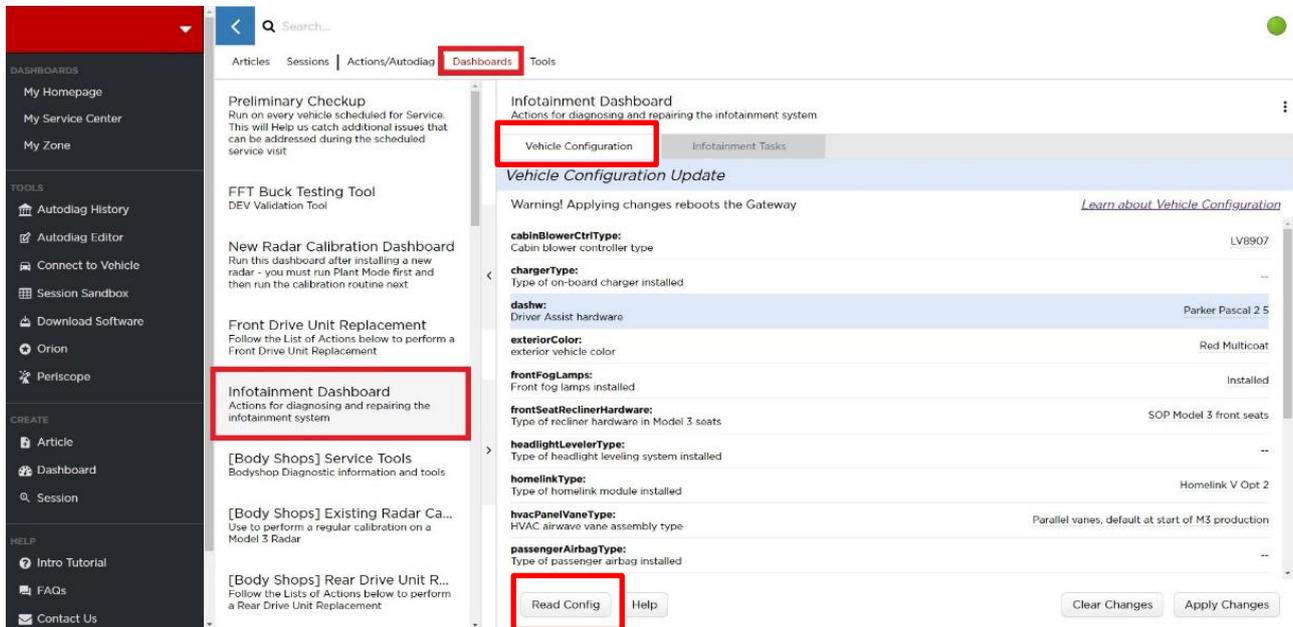
Figure 24

37. Close the LH rear door.
38. Repeat steps 16 through 37 for the RH rear door.
39. Connect a laptop with Toolbox 3 to the vehicle.
40. In Toolbox, click the **Dashboards** tab, click **Infotainment Dashboard**, click the **Vehicle Configuration** tab, and then click **Read Config** to display the current vehicle configuration (Figure 24).

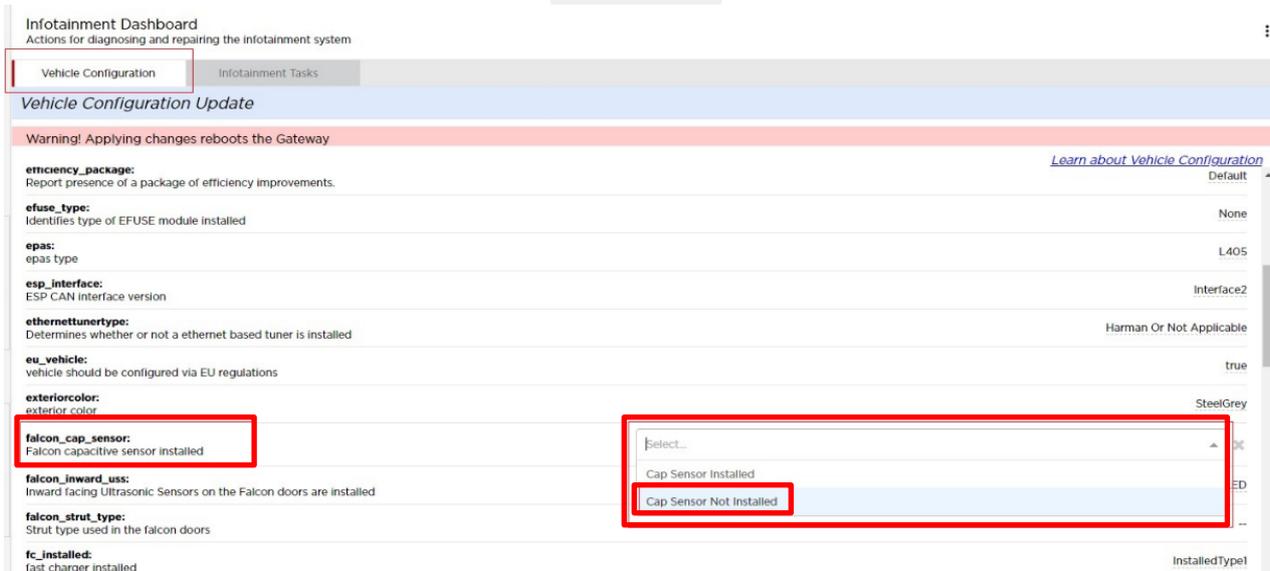
Figure 25

41. Scroll through the list to find “falcon\_cap\_sensor”, click on the drop down menu to the right of the text, and select **Cap Sensor Not Installed** (Figure 25).
