Tesla, Inc.
Service Bulletin

Inspect RH Front Wheel Speed Sensor

SB-24-33-006

November 6, 2024

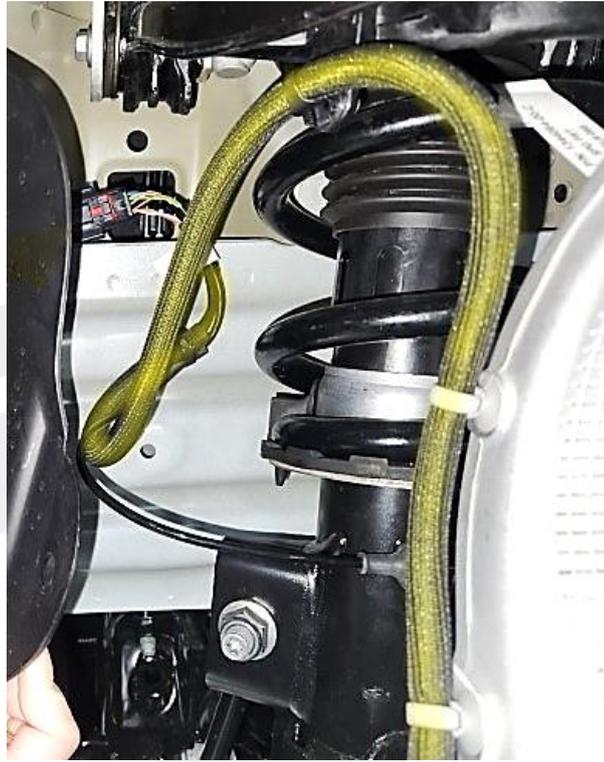
Figure 1 – RH front WSS harness; No damage present

1. Remove the RH front wheel assembly (refer to Service Manual procedure [34015001](#)).
2. Inspect the RH front WSS harness for indications of damage (Figure 1, yellow; and Figures 2–3).

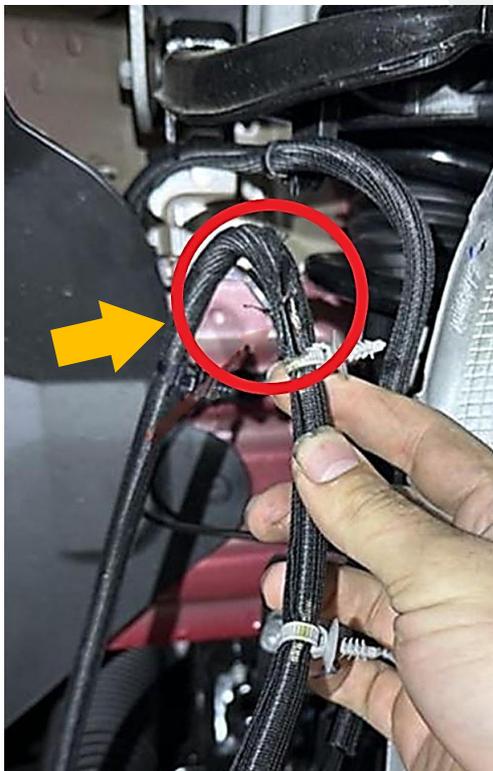
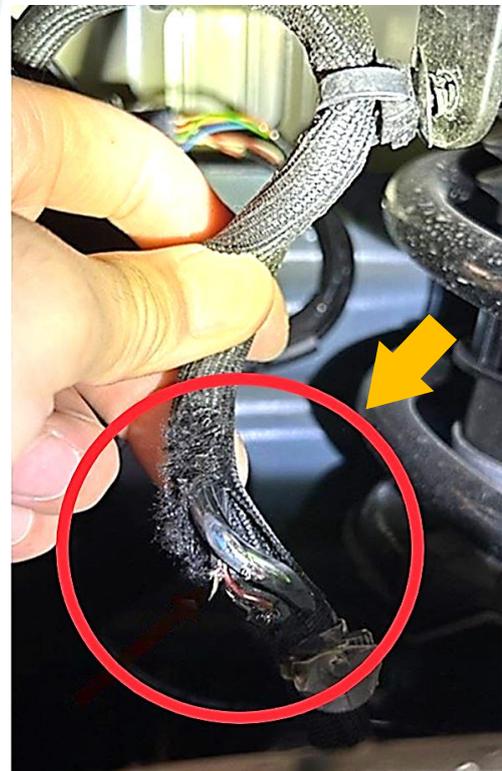
Figure 2 – RH front WSS harness; Damage present Figure 3 – RH front WSS harness; Damage present

- If damage on the RH front WSS harness is present, skip to step 5.
- If damage on the RH front WSS harness is not present, continue to the next step.

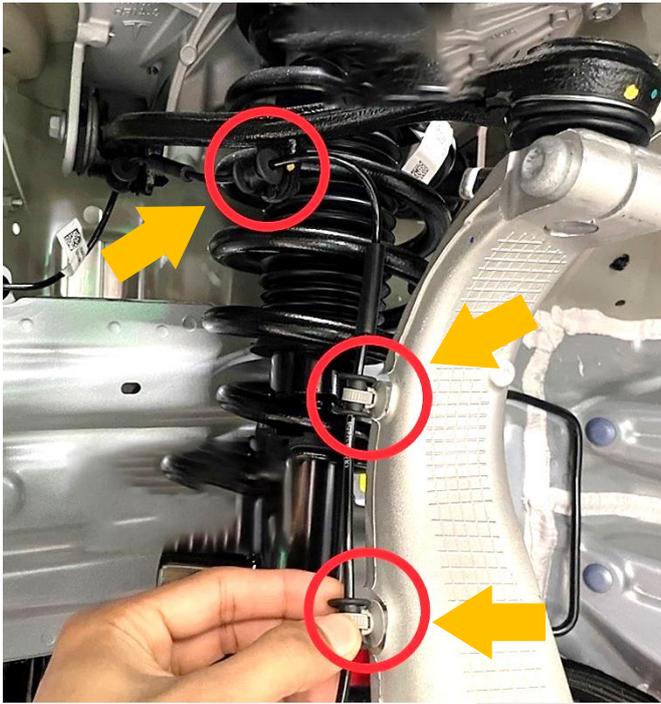
Figure 4 – RH front WSS harness clips installed correctly

3. Inspect the RH front WSS harness clips (x3) for proper installation (Figures 4 and 5).

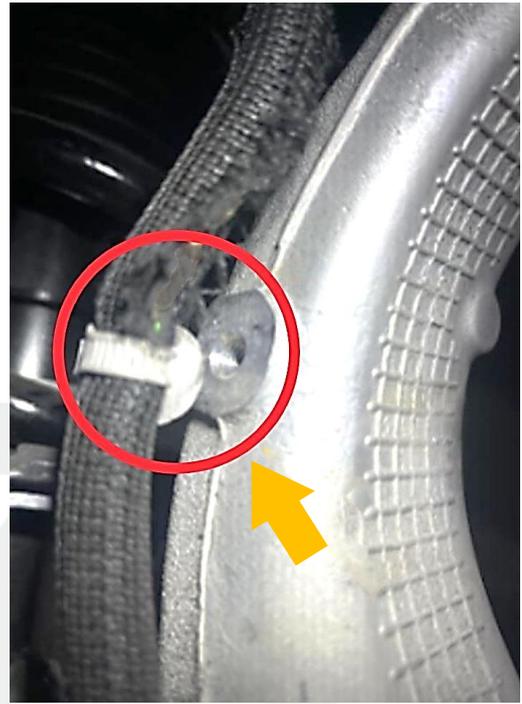
Figure 5 – RH front WSS harness clip not installed correctly

- If the RH front WSS harness clips (x3) are installed correctly, skip to step 6.
 - If the RH front WSS harness clips (x3) are not installed correctly, continue to the next step.
4. Fasten the clips (x3) that attach the RH front WSS harness to the RH front upper control arm and the RH front knuckle (Figure 4), and then skip to step 6.
 - ⚠ **CAUTION:** Ensure the harness is routed correctly to avoid contact with moving suspension components.
 - ⚠ **CAUTION:** Perform a push-pull check on each clip to make sure they are fully attached to the upper control arm and knuckle.
 5. Replace the RH front WSS (refer to Service Manual procedure [3310030002](#)).
 6. Install the RH front wheel assembly (refer to Service Manual procedure [34015001](#)).
 7. Close out this document using the appropriate correction code based on the repair(s) performed.
